SITA PRACTICUM INSPECTION REPORT

11753 Treehouse Trl
Justin, TX 76247

PROPERTY INSPECTION REPORT FORM

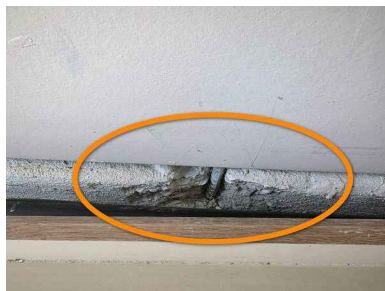
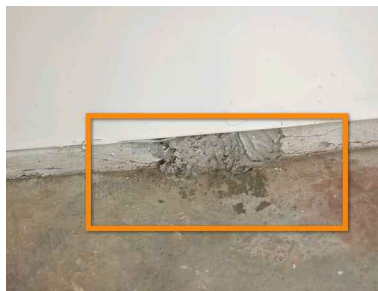
1: Poor Repair/Concrete Needs Repair

Garage

There were multiple areas where the concrete was patched and/or needs patched. The way that it is patched appears to be poorly done.

Damaged concrete results in a weaker, less durable floor, prone to cracking, crumbling, and spalling, which can cause structural damage Recommend a masonry Contractor fix this.

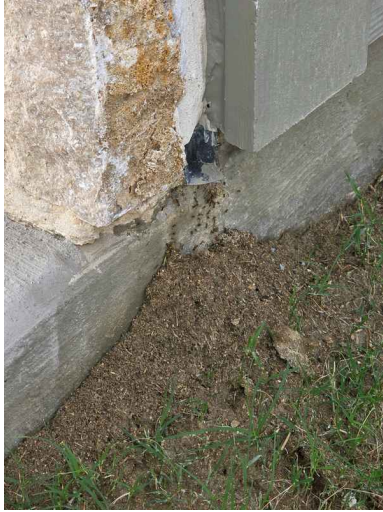
There was an ant bed noted to be up against the house. Having pests up against house can cause them to enter home. Recommend putting out granules for ants.

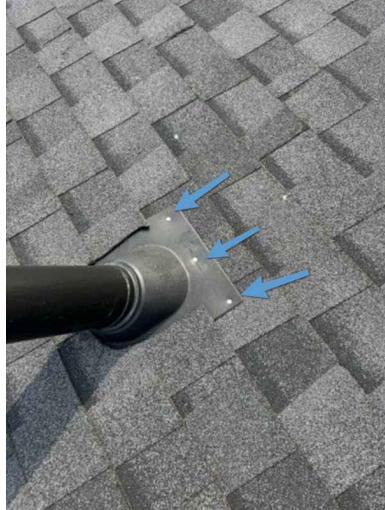
1: Exposed fasteners

There are exposed fasteners on the roof. Sealant should be applied to exposed fastener heads to prevent moisture from penetrating the roof in those areas.

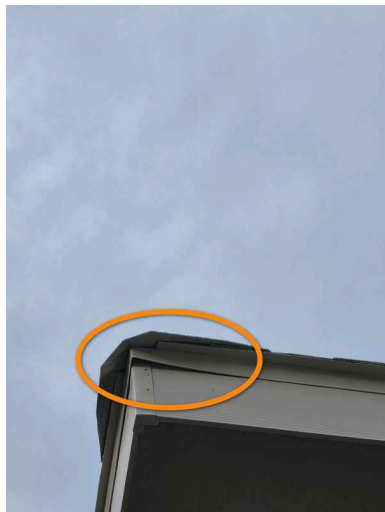
2: Drip edge not secured

The drip edge was not secured in one or more places on the fascia. This can lead to moisture intrusion. Recommend having roofing contractor evaluate and fix.

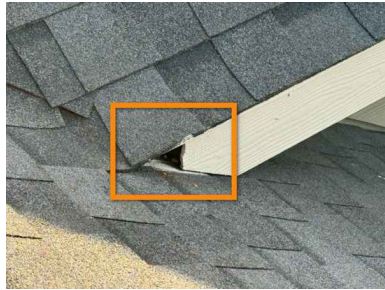
3: Fascia board cut too short

The fascia board overhanging the roof is cut too short. This can cause moisture penetration and pests to enter the home. Recommend siding contractor evaluate and fix

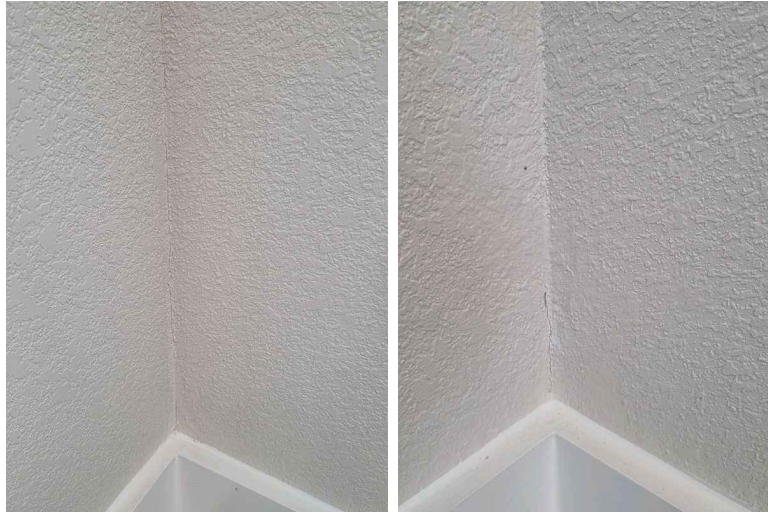
1: Seal caulk joints at wall trim

There are separated caulk joints at the interior wall trim at one or more locations. The joints should be sealed to help prevent moisture penetration in those areas.

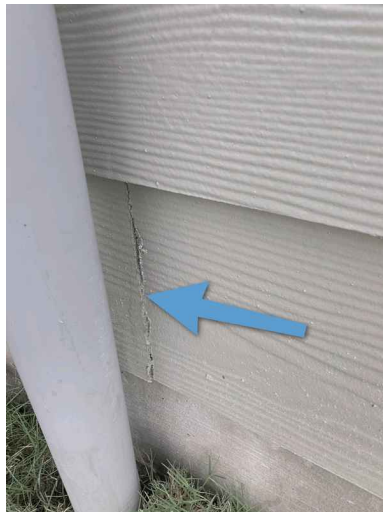
2: Wall penetrations not sealed

There are one or more exterior wall penetrations that are not sealed. The penetrations should be sealed to help prevent moisture and/or pest intrusion in those areas.

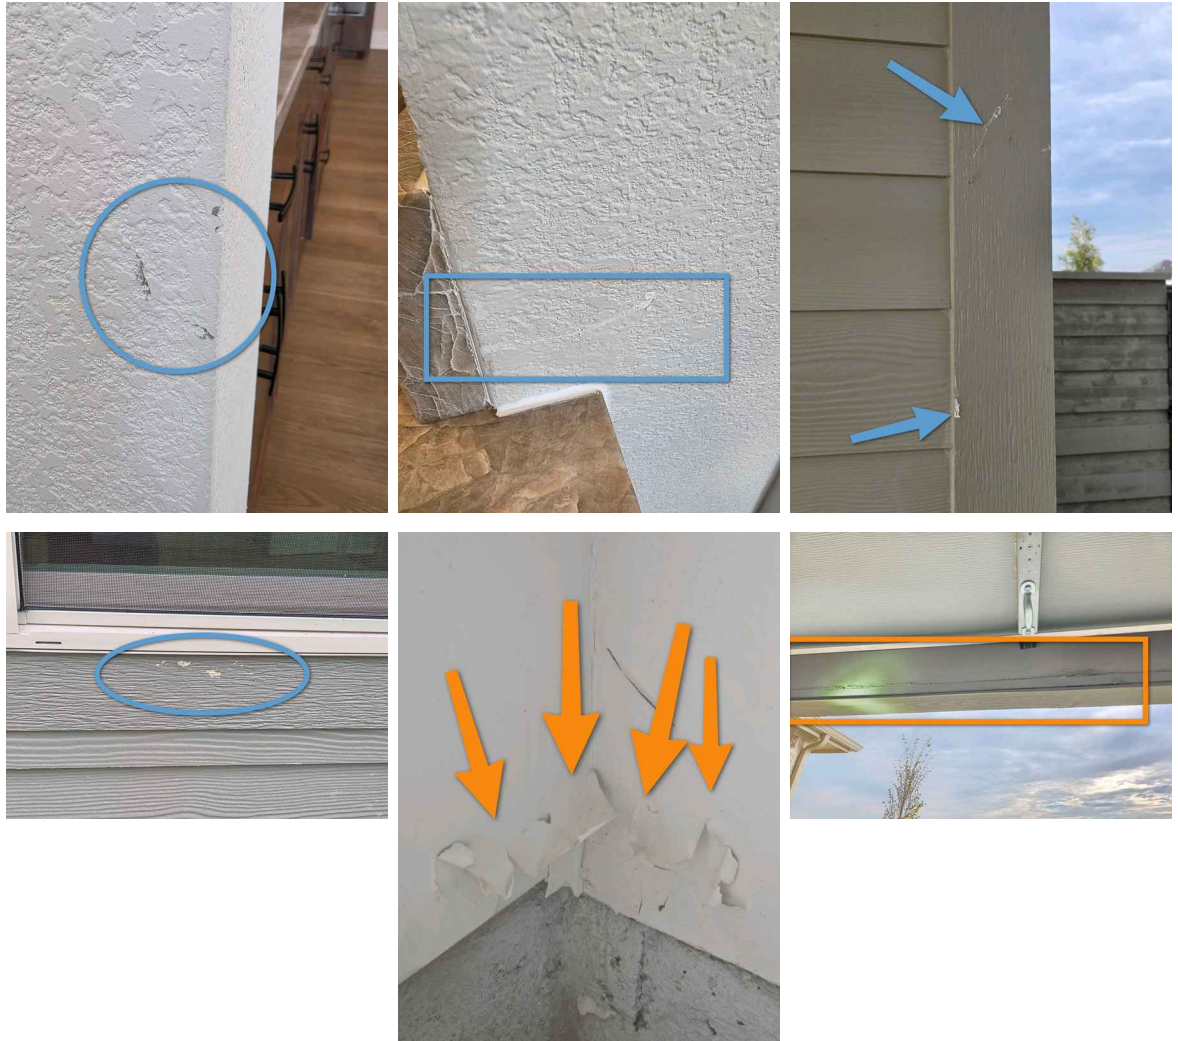
3: Scuffed walls

There are multiple areas on the inside and outside of the home that have scuffs or paint on them. This is a cosmetic issue but if it is a problem for you, I recommend having the builder fix

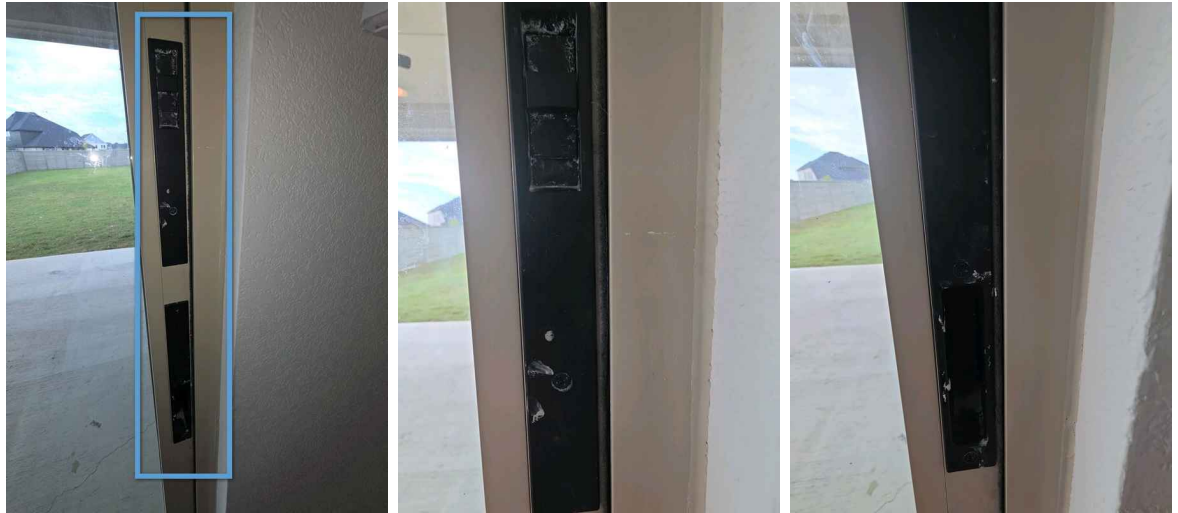
4: Handles Dirty

There are one or more areas that have buildup/drywall mud on the handles. Recommend cleaning off to allow door to lock properly.

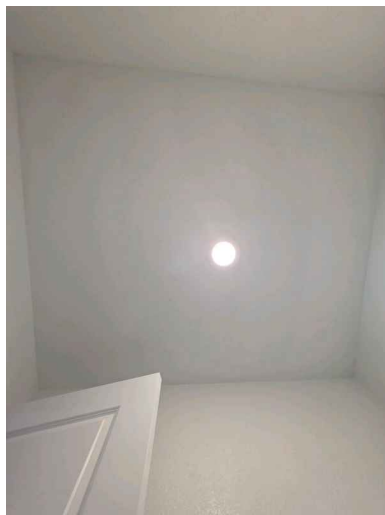
5: Ceiling not painted

The ceiling was not painted only textured. This can lead to difficulty when cleaning the walls, as the texture can rub off. Recommend painting to ensure easy cleaning and sealing of room

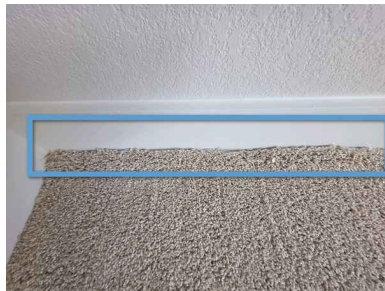
2: Carpet not secured

The carpet is not secured in the upstairs bedroom. This can lead to damage to carpet, decreasing the lifespan of it. Recommend fixing

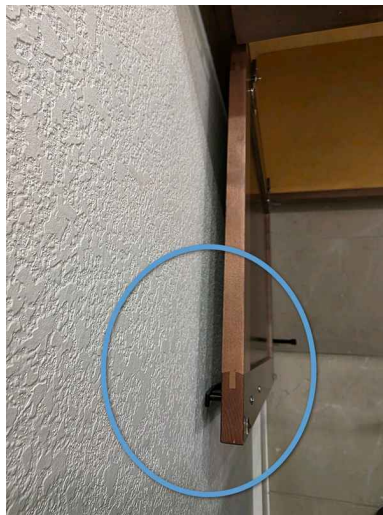
2: Cabinet Doors Hits Wall

The Cabinet door Hits the wall. This can lead to damage to the Cabinet handles, as well as the drywall. Recommend fixing.

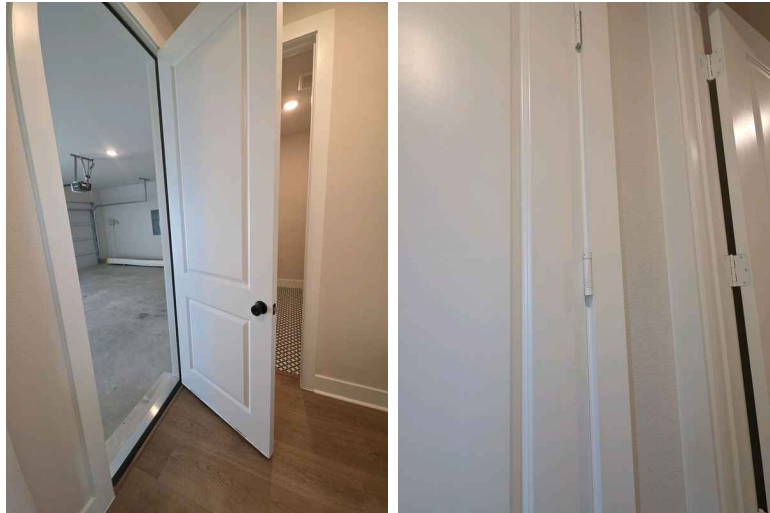
3: Garage Door does not Auto Close

The garage door should automatically close after opening, as it is a safety hazard if it does not. This is to help slow a fire down if one starts in the garage. The pins are present in the hinges but not activated. Please activate the pins so the door closes automatically on its own.

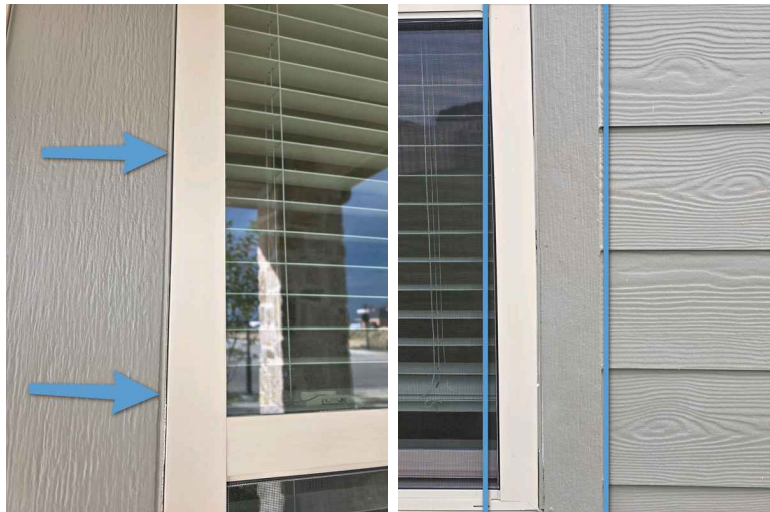
1: Exterior window deteriorated caulk joint

There are separated caulk joints around the exterior window frames at one or more locations. This may indicate settling and/or seasonal movement in those areas. The caulk should be touched up or replaced to exclude pests and moisture from those areas. Where deteriorating caulk is noted it should be assumed that some moisture penetration has occurred and that some hidden damage may be present.

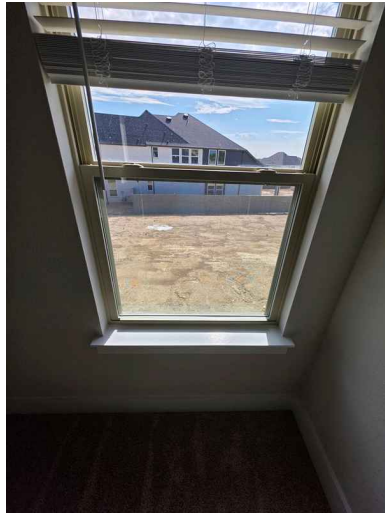
2: Windows too high for emergency egress

The bedroom window(s) do not meet the required floor height for emergency egress. Each bedroom should have at least one window within 44 inches of the floor. The construction of this house may predate this standard.

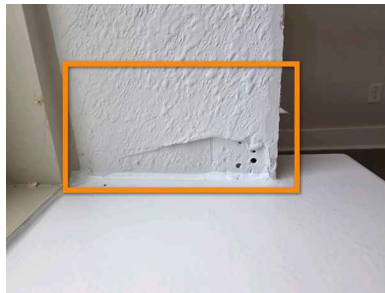
3: Exposed cornerbead

There was exposed corner bead at one or more interior windows locations. This makes the corner more prone to damage from impacts and compromises the corners appearance and integrity. Recommend a painter/handyman fix

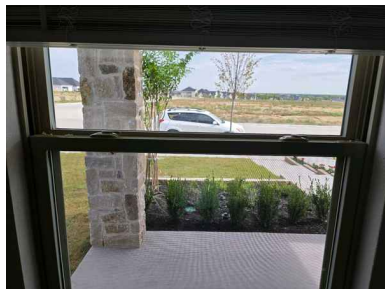
4: Windows Difficult to Lock

One or more Windows in the home was Difficult to Lock after opening. A decent amount of force was needed to get Windows to Lock. Recommend having a licensed Windows professional fix.

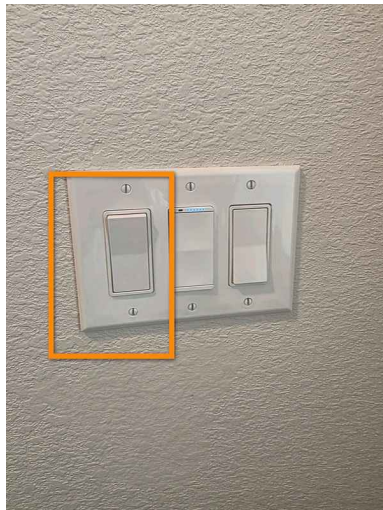
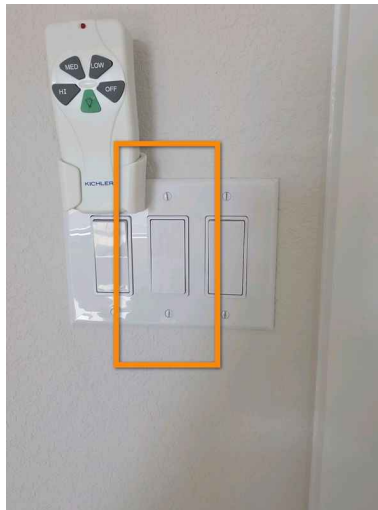
1: Unknown light switch location

There were one or more locations where the light switches did not operate anything. Recommend speaking with electrician about what the switches run to. Have electrician evaluate and fix

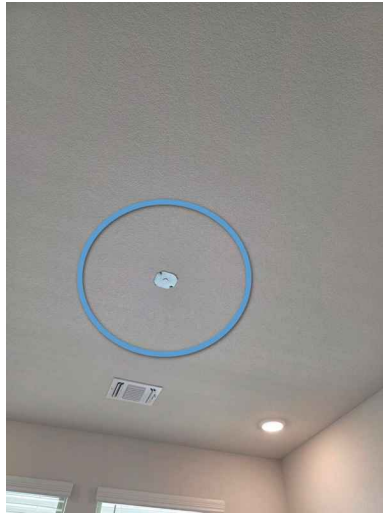
2: Fan missing

There is a lightswitch installed for a fan but there is a coverplate where the fan should be. Recommend builder install fan before closing

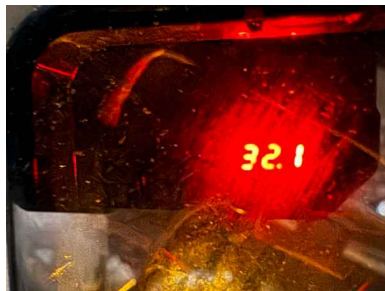
1: Heater Did Not Turn On

When attempting to test emergency heat, the furnace would not turn on. It gave this error message on the inside unit. Recommend having a licensed HVAC contractor evaluate.

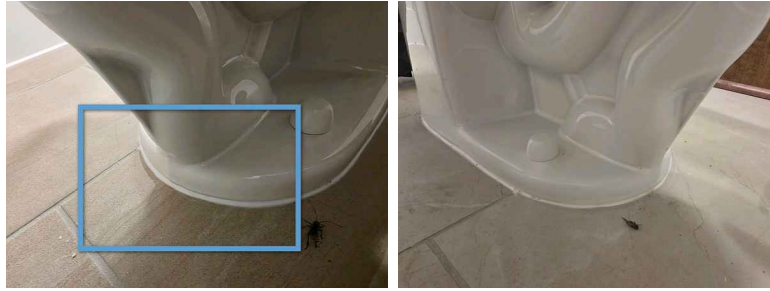
1: No Gap in Caulk

There was no gap in the caulking, around the base of the toilet. This is an issue if there is a leak, because it will go unnoticed and cause damage. Recommend leaving 2 inch gap at the back of the toilet, to notice if

there is leaking

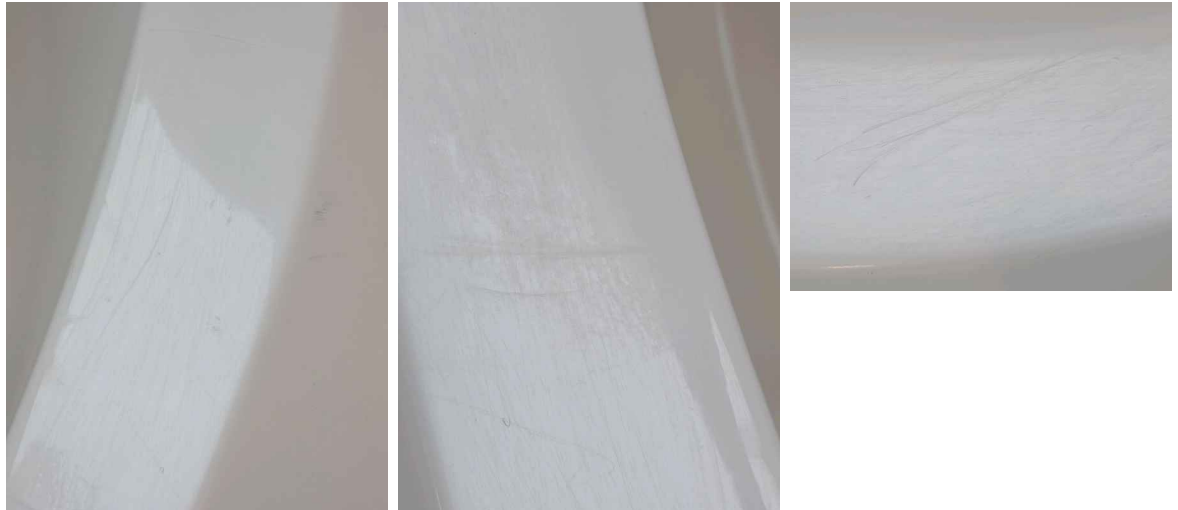
2: Superficial Scratches on Bathtub

There were superficial scratches noticed on the bathtub in the master bathroom. If this is an issue for you, recommend having bathtub specialist come out to remedy/replace

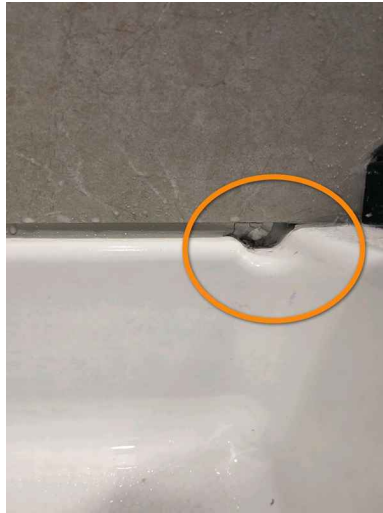
3: Gap needs filled in shower.

There is a gap between the shower pan and the tile that needs sealed to prevent moisture intrusion behind the tile. Recommend properly sealing.

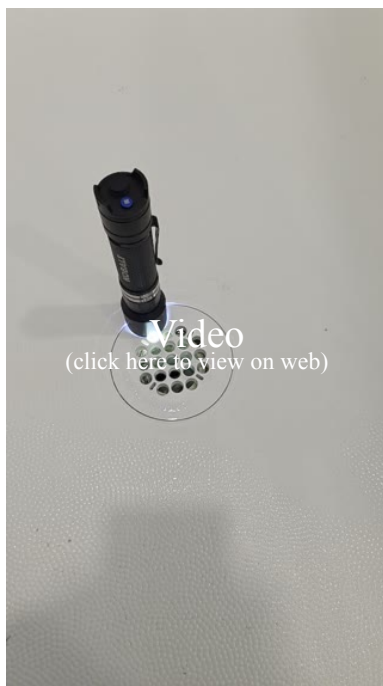
4: Debris in Shower Drain

There is debris built up in the drain line of the shower. This can lead to water backing up the drain and clogs. Recommend removing debris

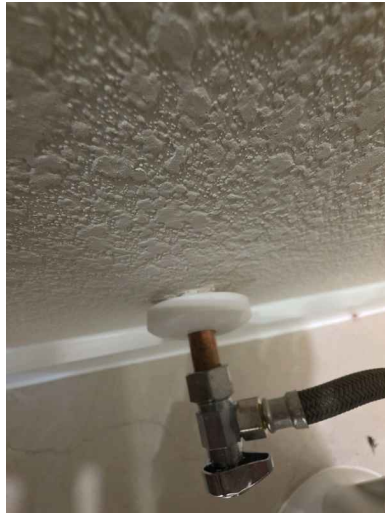
5: Toilet supply line cover not sealed

The Coverplate for the toilet supply lines should be pushed all the way against the wall and sealed. Recommend properly sealing.

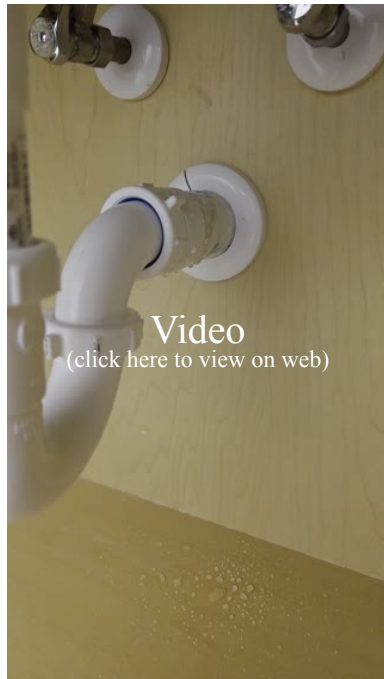
1: Drain leak under sink

A drain leak was observed under one or more sinks. Further evaluation and/or repair by a licensed plumber is advised.

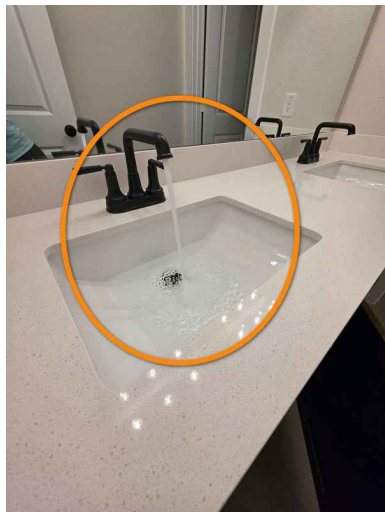
2: Poor/Slow Drainage

Poor/slow drainage was observed at time of inspection. Recommend a qualified plumber evaluate and repair.
